SHMS Aerogel Update
10/4/2017

Overnight run #1204 (standard settings)

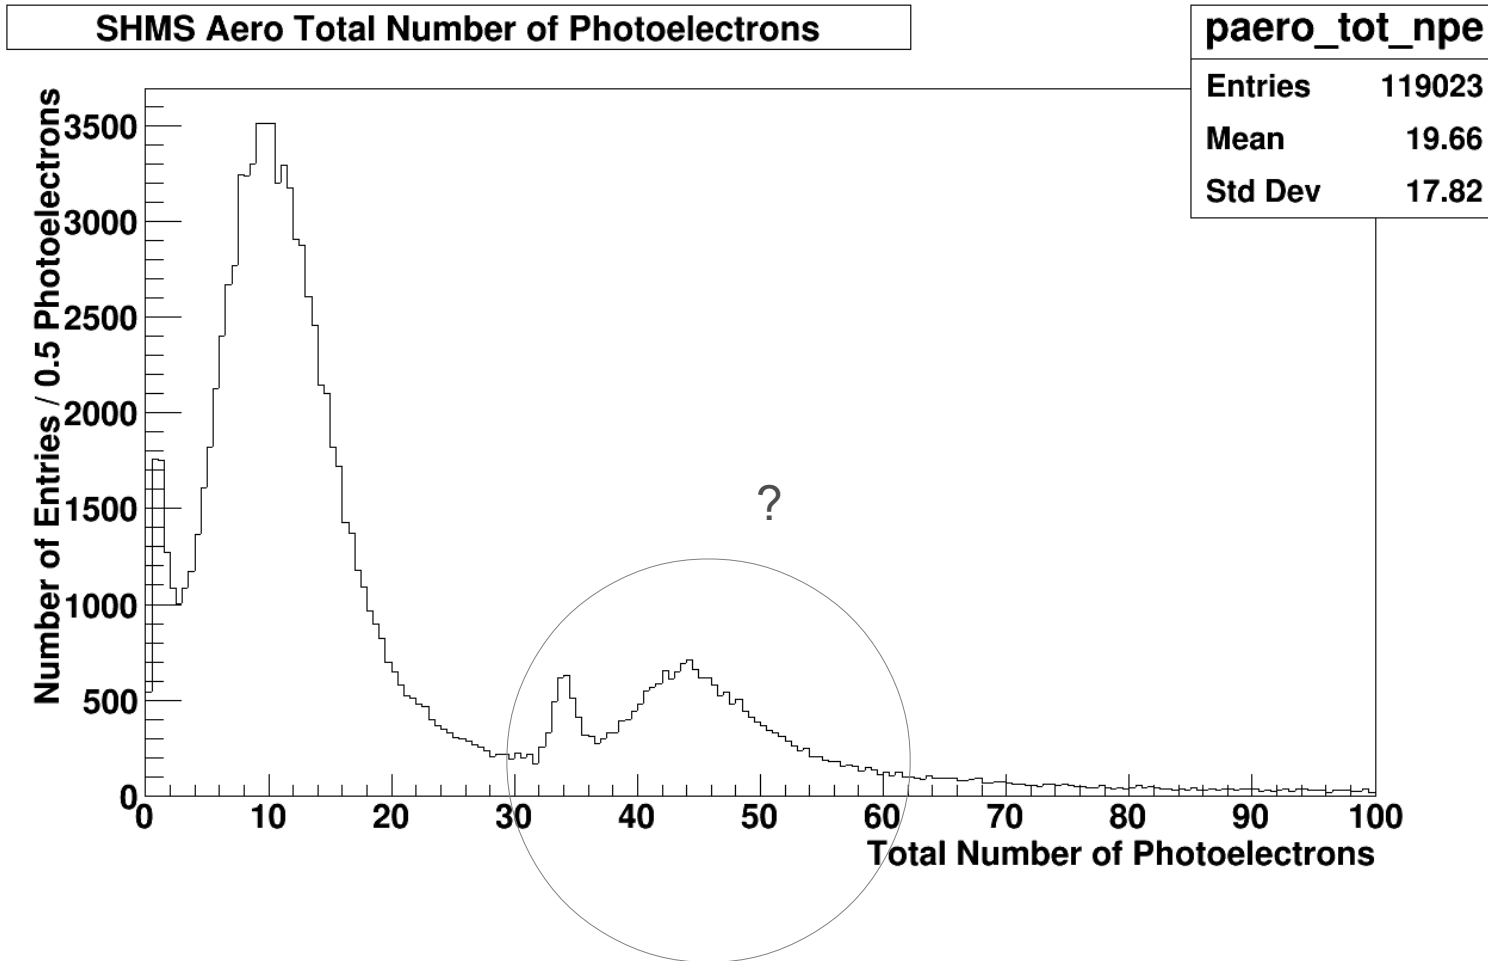
- 1) Discovered that ch#6(negative) was noisy (Main contribute to additional P.E. peak in spectra).
- 2) Checked with the scope ch#6 and other channels. No visible problems.

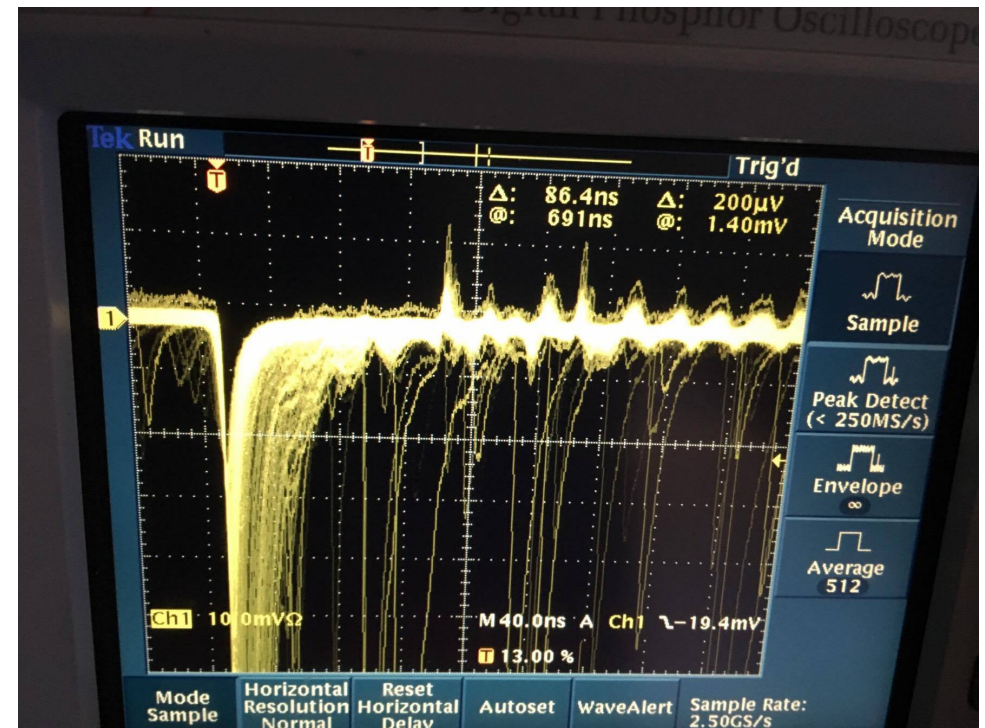
Ch#6 Negative

PMT#6(Negative) could cause the problem itself ?

- 1) Total P.E. Spectra looks good with new analyzer
- 2) Ch#6(Negative) still questionable

Could the change of this PMT with spare before physic run solve problems ?
- 3) Need long (2 day) run to figure this out

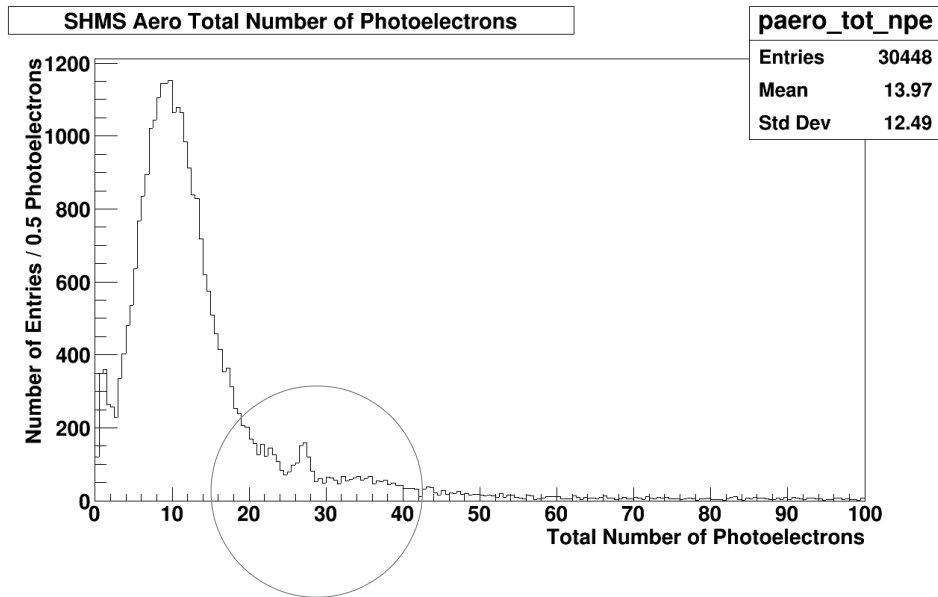
Old analyzer version

Eric : “ FlashADC 250 decoder had problem in old version of Analyzer.
Some pedestals was corrupted and have not been subtracted.”

With Eric's help new version HCANA was installed.

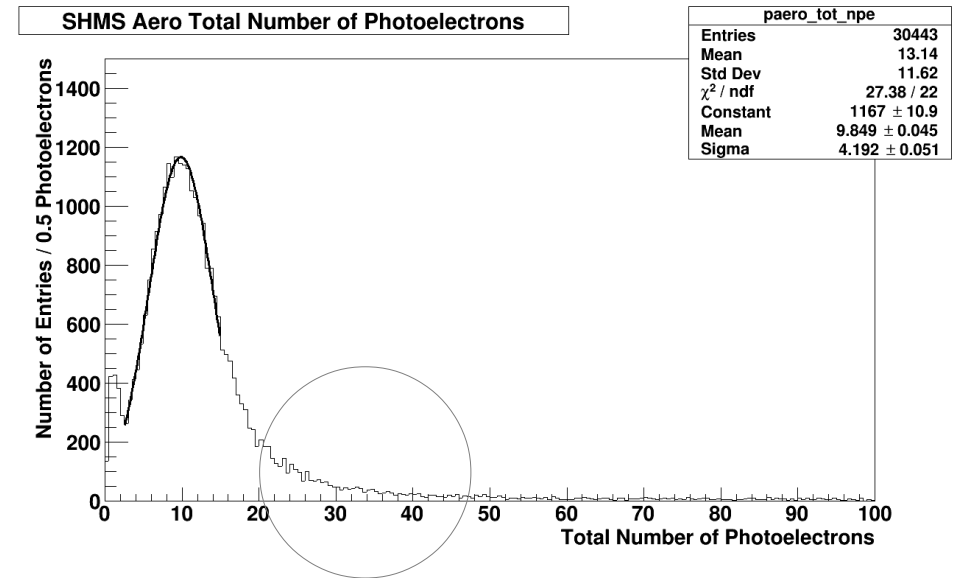
Current analyzer version

same short cosmic run 1227
