SHMS Aerogel Update
10/4/2017

Overnight run #1204 (standard settings)

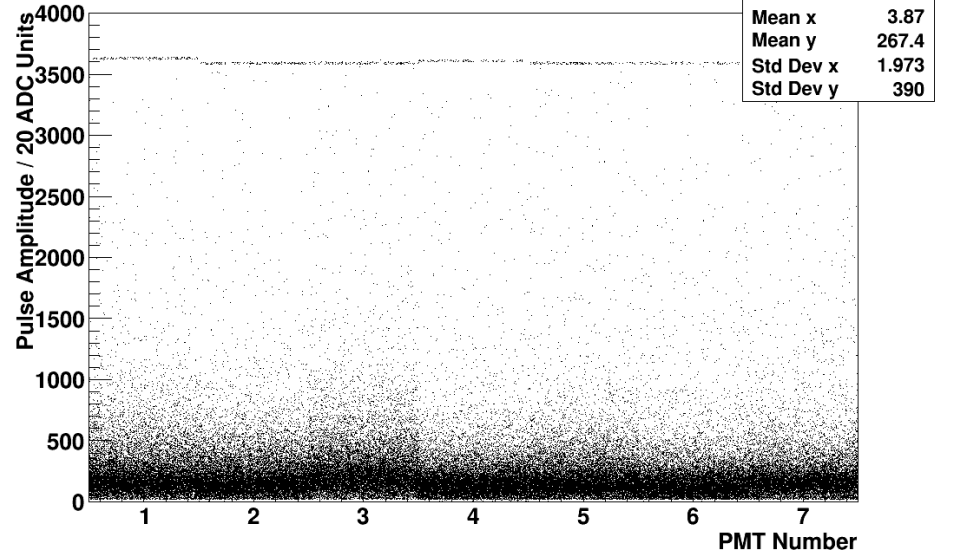
SHMS Aero- Good Pulse Amplitude vs. PMT Number

- 1) Total P.E. Spectra looks good with new analyzer
- 2) Ch#6(Negative) still questionable
