Week 2

Task 1: Re-examine J18 and J19

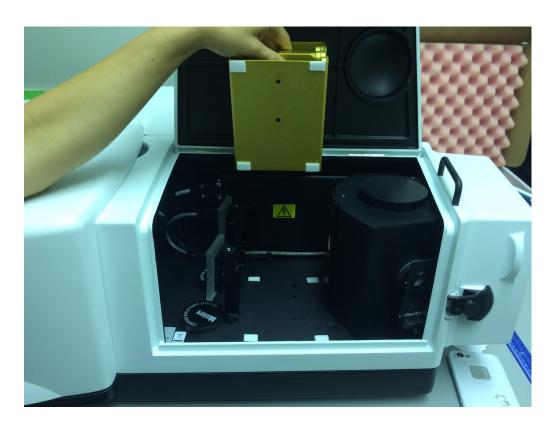
Recently Added: Velcro

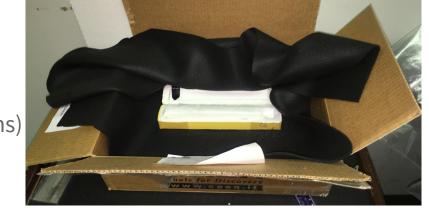
- -J23: 70mins of irradiation (### crystal was 60mins)
- -Shelf 8 plus 11.45cm tall platform

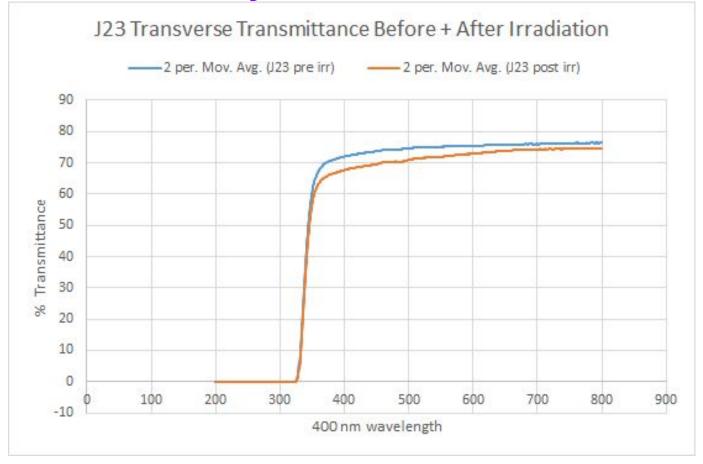
J23 Before/Directly after Irradiation

- -When removing the crystal after irradiation, had lights off in room and closed door
- -Wrapped the crystal in the dark, placed in its styrofoam container
- -Then was put inside a cardboard box lined with a black rubber cloth, covered, brought down to spectrometer room 5 minutes later where lights were off as well

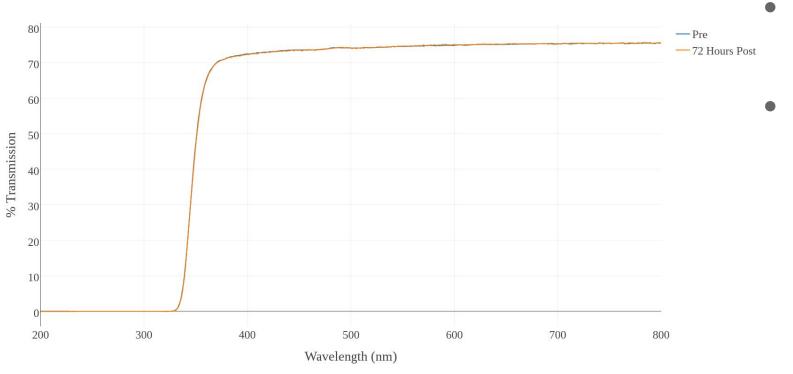
"###" Crystal Recovery 72 Hours Post-Radiation

Transmission fully recovered

Stored (unwrapped) in office

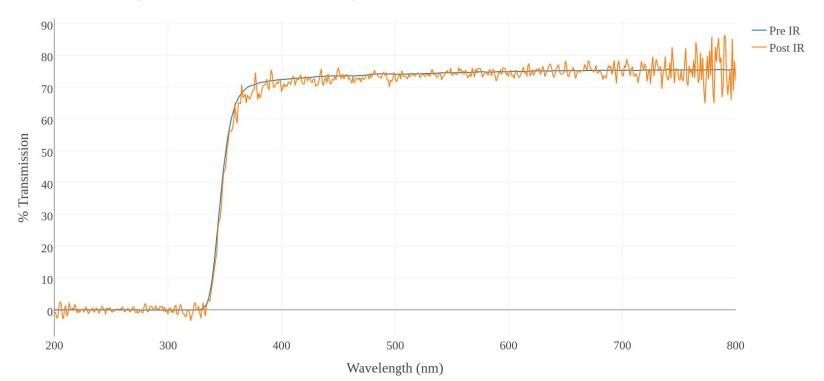
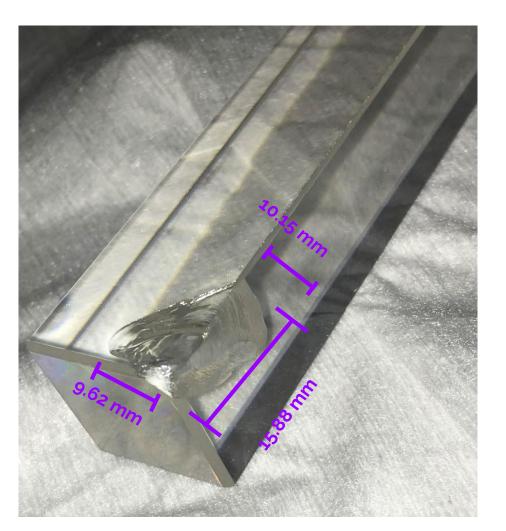
- Spectrometer difficulties
- Solution= place fan next to Spectrometer

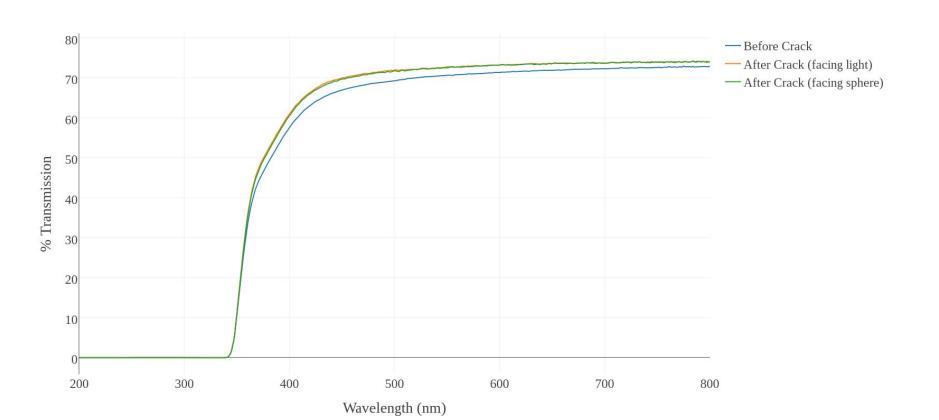
J21 Incident

Lid of spectrometer fell on crystal

J21 BC & AC Longitudinal Transmission
